Manhole Inspection Summary

Manhole # S41Y1_031MH

Insp Date: **5/6/08 12:34 PM**

Location Address: **626 E. Patapsco Ave.**

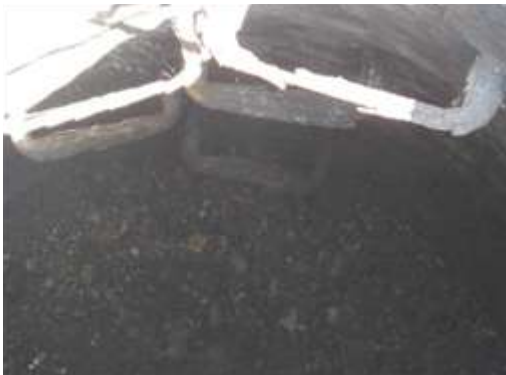
Steps Count: **5** Missing: **0** ☒ **Corroded**

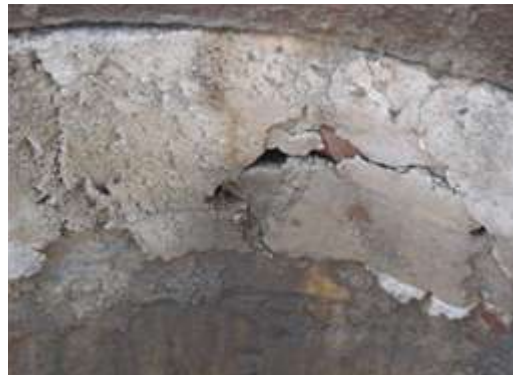
Defect 1

Condition: ☐ Sound ☒ **Cracked** ☐ Root Intrusion ☐ Loose Brick ☐ Deteriorated

Infiltration: ☐ None ☐ Joint ☒ **Cracks** ☐ Mortar ☐ Roots ☐ Wall

Cracked Chimney

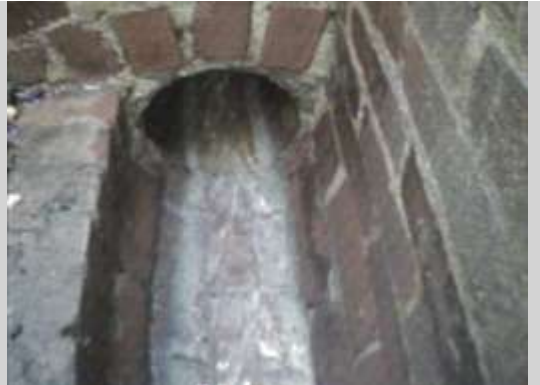
12 O'Clock Outflow

Pipe Height: **8.4** (in.) Rod and Bar (Angled)
Pipe Material: **Clay** ☐ Pipe Lined
Invert Depth: **11.20** (ft.) Flow Characteristics: **Fast**
Deposits: ☒ None ☐ Mud ☐ Sludge ☐ Debris ☐ Grease
Silt Depth: (in.) Deposits Extent:
Infiltration: **None** Pipe Seal Cond: **Sound**

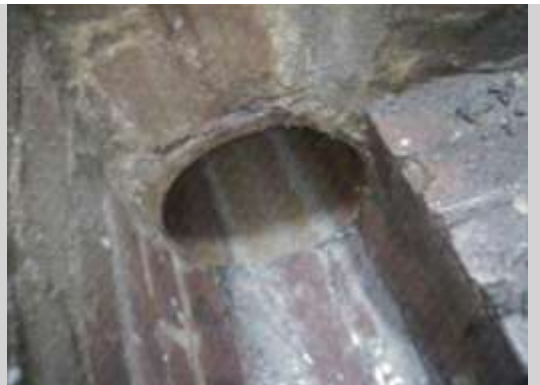
6 O'Clock Inflow

Pipe Height: **8.4** (in.) Rod and Bar (Angled)
Pipe Material: **Clay** ☐ Pipe Lined
Invert Depth: **11.00** (ft.) Flow Characteristics: **Fast**
Deposits: ☒ None ☐ Mud ☐ Sludge ☐ Debris ☐ Grease
Silt Depth: (in.) Deposits Extent:
Infiltration: **None** Pipe Seal Cond: **Sound**
